OVERVIEW OF THE MAGNET ACTIVITIES AT HIT

R. Cee*, A. Gaffron, T. Haberer, A. Peters, F. Schelb, S. Scheloske, J. Suhm
Heidelberger Ionenstrahl-Therapiezentrum, D-69120 Heidelberg, Germany

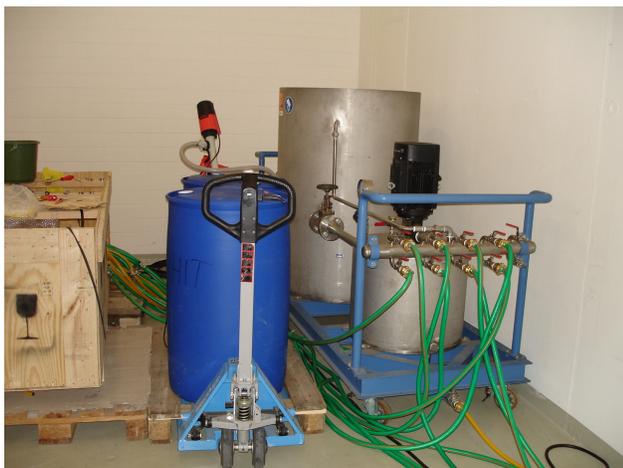
Figure 2: Passivation device from GSI Darmstadt connected to a spare coil.

The passivation has also been performed for the spare coils. With the help of a special passivation device built by GSI Darmstadt (Fig. 2), mainly consisting of a vessel and an immersion pump, a thin solution of the copper inhibitor has been pumped through the cooling channels of the coils for up to three days. Afterwards the channels have been rinsed with demineralised water for one day. After drying with compressed air and filling with nitrogen the conductor ends have been sealed and the coils put into stock.

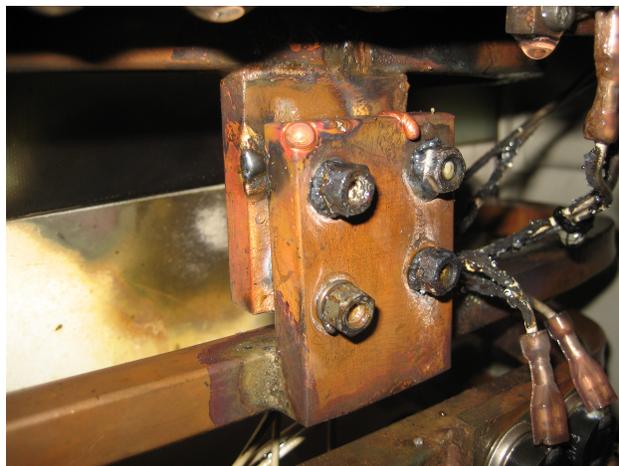
One of the first and most crucial magnet failures occurred in November 2007. HIT has still been in the commissioning phase when beam time was stopped by a failure of one of the two 45° -dipoles into the first horizontal treatment room. The on-site inspection revealed a terrible sight: the plexiglass cover of the electrical connection box was charred and water was running on the ground. From more detailed inspection the reason for the mess could be found: loose screws at the electrical bridge between the upper and lower dipole coil, two copper bricks brazed to the conductors, caused a bad contact. As a consequence the current flew via the screws instead the contact face. This led to an enormous heat evolution and the described scenario. Every endeavour has been made to fix the damage as quick as possible. After three days of preparation including machining of melted parts and cleaning of the connection box, the repair of the electrical and water connections was performed with support of GSI Darmstadt. After 13 hours repair time the magnet could go into operation again. As a consequence of this incident all screws in the connection boxes have been checked for tightness. We have found another magnet with partly melted copper bricks and replaced these preventively.

Figure 3: Electrical bridge in the magnet connection box after contact problem.

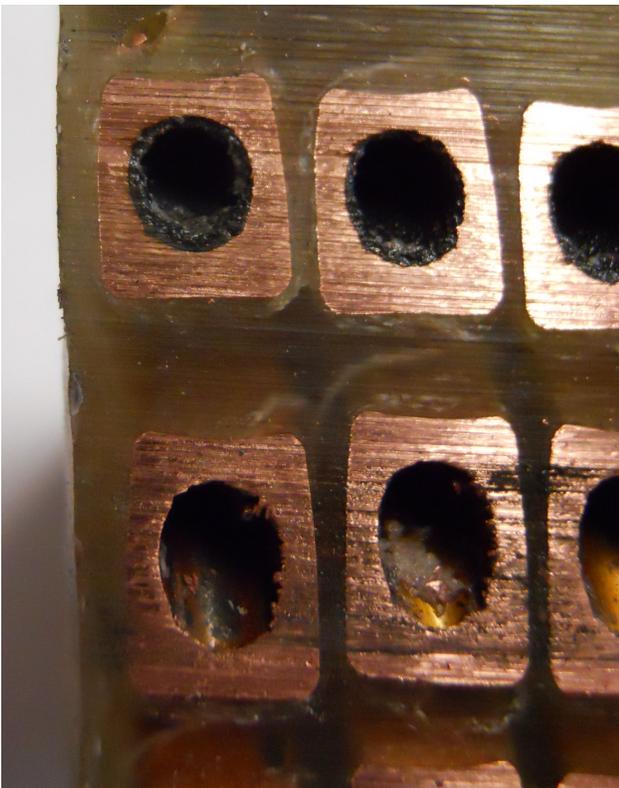
It was in November 2010 when first problems with the inflector magnet into the synchrotron appeared. The operation of the dipole magnet was interrupted due to an interlock caused by the thermo-switches in the magnet connection box. From pictures taken with a thermal imaging camera it was obvious that we deal with a real temperature limit violation. It could also be seen that the temperatures of the four cooling circuits show large differences and that especially one circuit (upper circuit of lower coil) had temperatures which definitely exceeded the switching temperature of the thermo sensors (70°C). Detailed investigation of the cooling system followed revealing a 50% reduced water flow of the critical cooling channel compared to the specification (2 l/min). It was also suspicious to find a black powder in the cooling water at the outlet which could later on be identified as CuO by means of an X-ray diffraction analysis. As the blockage could not be resolved by simple water rinsing, the thermo switches were selectively replaced by sensors with a trigger temperature of 100°C . With this the operation could be continued for three months until the temperature interlock appeared again. The critical circuit was then connected to a separate connection available at a cooling water distributor of the synchrotron and the water flow direction was regularly alternated. This allowed us to continue operation. As an attempt by a professional company to unblock the water circuit with special chemicals failed, we finally replaced both coils of the magnet during the summer shutdown 2011 with the spare coils in stock.

Figure 4: Copper oxide (CuO) layer inside the cooling channel (nominal diameter 4 mm) of the inflector coil.

For HIT it was essential to understand the reason of the plugging to be able to react adequately if a similar problem occurs again. We therefore performed several tests with the dismantled coils at the supplier site [6], investigated the deposit under an optical microscope and finally cut the coils into pieces. This showed the whole extent of the problem (s. Fig. 4). The corrosion layer on the surface of the cooling channel reduces the effective diameter considerably explaining the low water flux. One could also discover that the thickness of the corrosion layer increases from the cooling water inlet to the outlet. As a consequence we doubled the number of cooling water connections from four to eight when mounting the new coils and thus reduced the maximum temperature in the coil significantly. This should slow down the corrosion process to an acceptable measure.
