News from structure production task force – T18_CERN

G. Riddone on behalf of the
task force team

20.03.2009

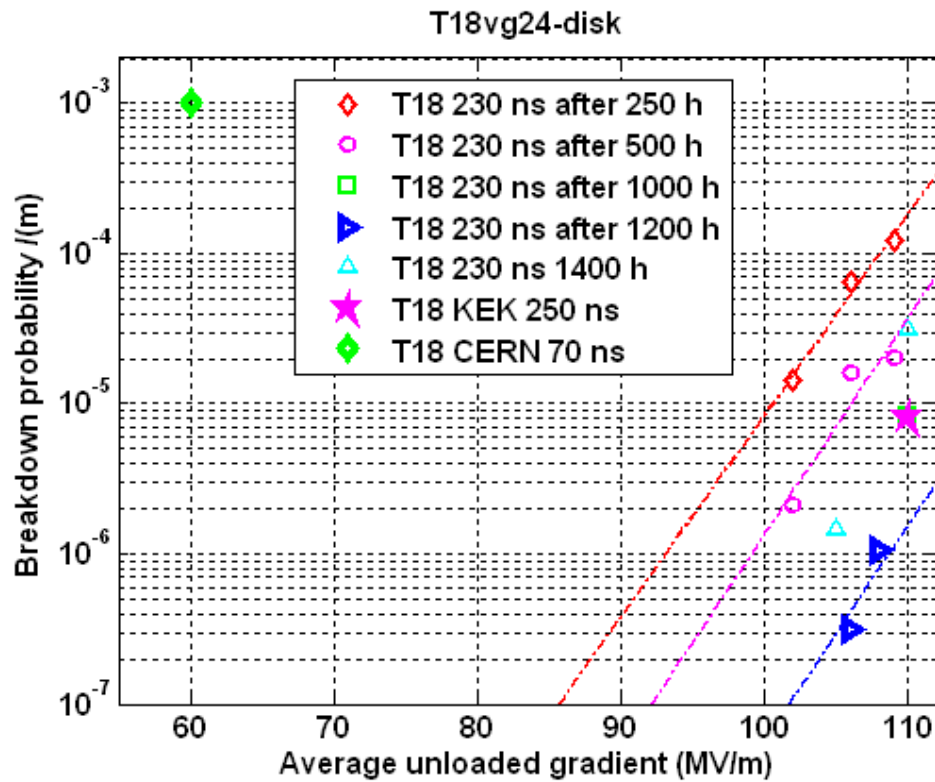
T18 high power test results

'Hot' cells 13 +15

Breakdown distribution of
 T18Disk_SLAC (red, last 500hrs),
 210~230 ns, 110~120 MV/m
 T18Disk_CERN (Blue, 40hrs).
 180 ns, 45~49 MV/m

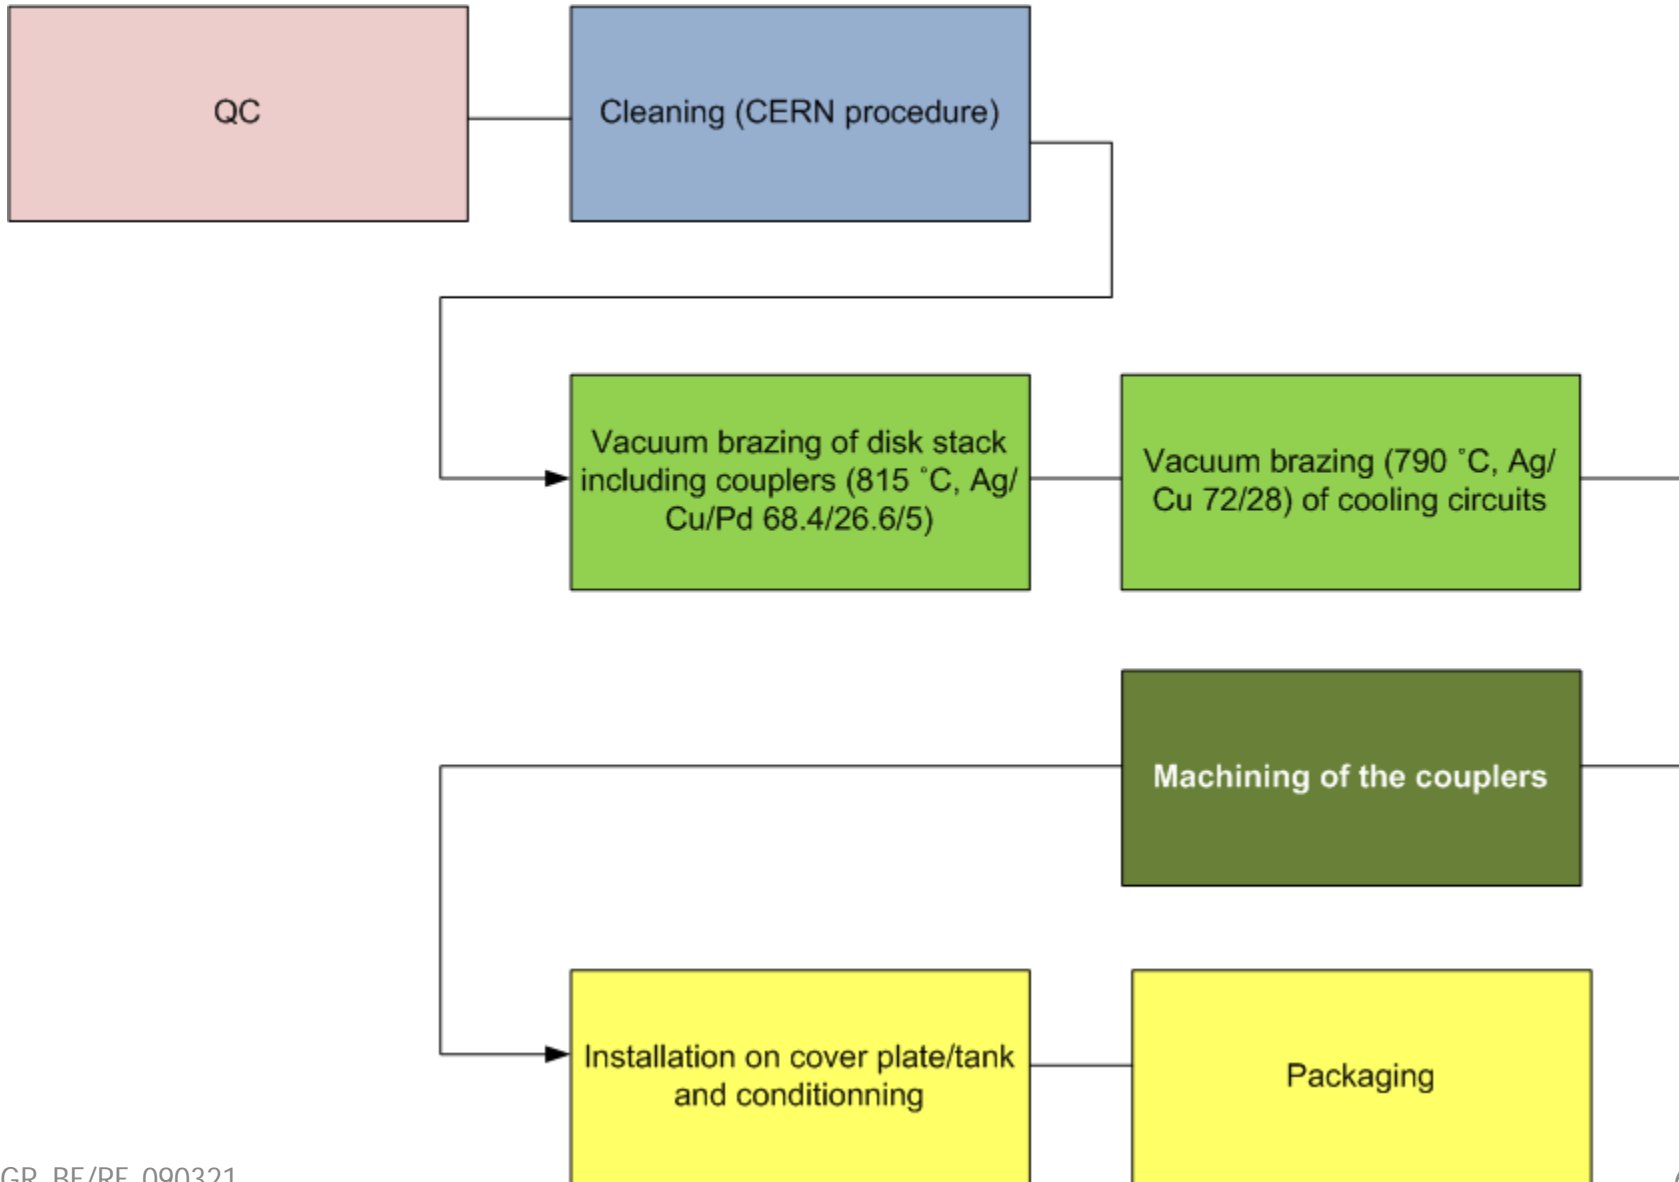
T18_CERN followed the nominal CERN assembly cycle

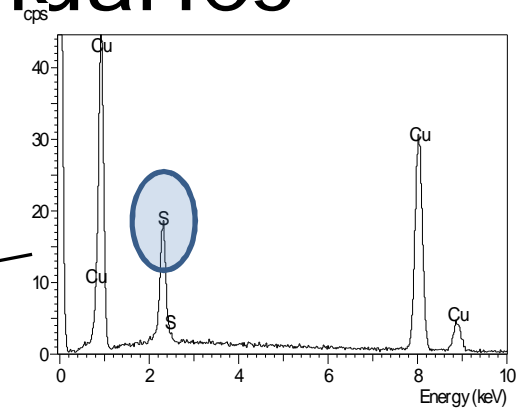
Piece 2, Iris 4

Craters at grain boundaries

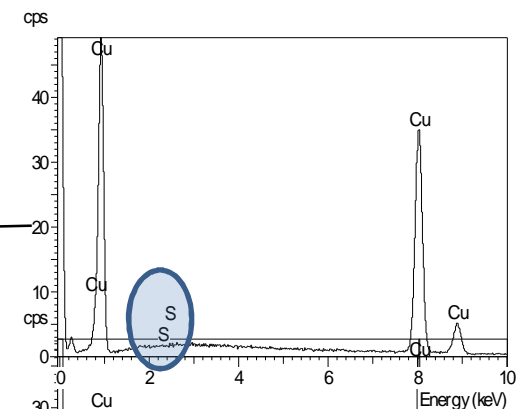
Presence of small craters
→ association with soft breakdown
→ S-residue in some craters

- S-rich particles in the grain boundaries
 - association with soft breakdown
 - S can be present in Cu-OFE up to 18 ppm
 - completely soluble above 750 °C but in equilibrium – slow cooling – forms Cu_2S at room temperature
- Grain size could be an issue
- Cleaning/handling procedures shall be improved
- Additional steps on dimensional control and SEM are required during preparation

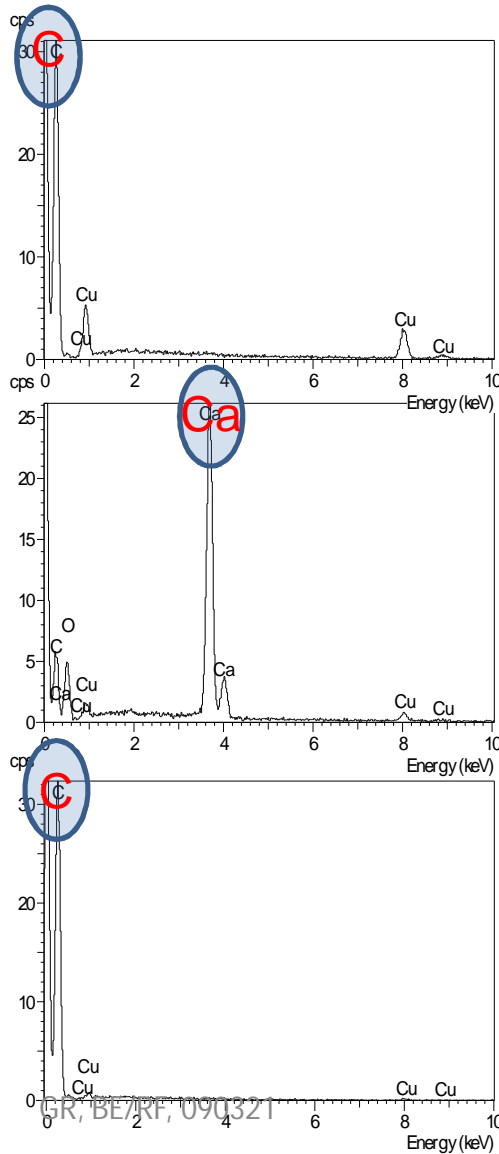
Inspection on iris 12

Contamination between brazing and testing

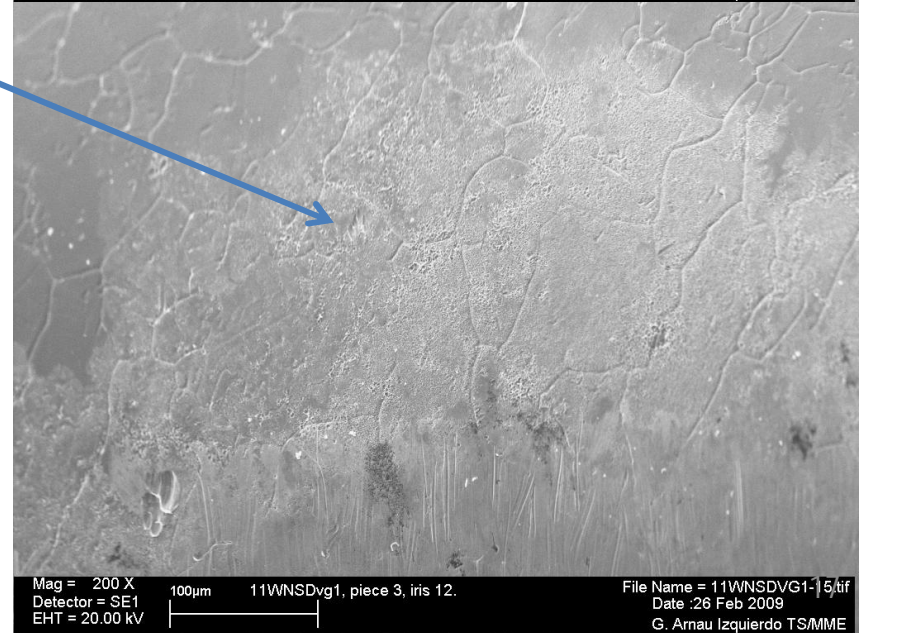
Inspection on iris 12

Region of craters

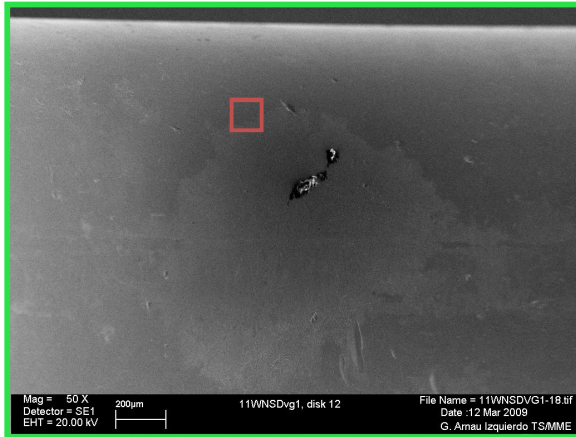
Inspection on iris 12

Sulfur features also in bulk material

In agreement with technical specification
