Workshop on Accelerator Operations
August 6-10, 2012

Bevatron Decommission and Demolition

Lawrence Berkeley National Laboratory

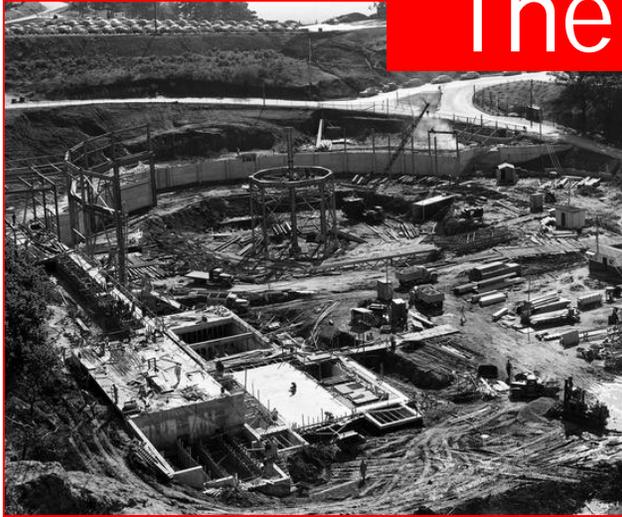
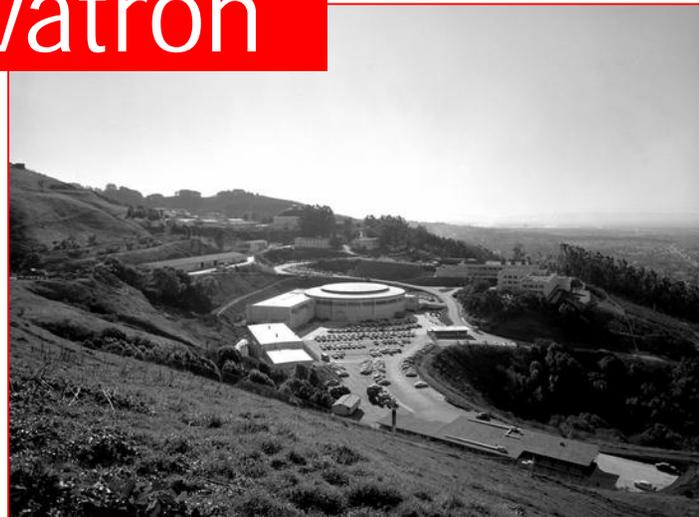
- The Bevatron was built in the 50' s at the Berkeley' s Rad Lab for a cost of \$9 million (~\$76 million 2012 \$\$).
- It began operation in 1954.
- Bevatron was initially a proton accelerator.
- It was built to discover the **anti-proton** (discovered in 1955).
- They also discovered the anti-neutron.

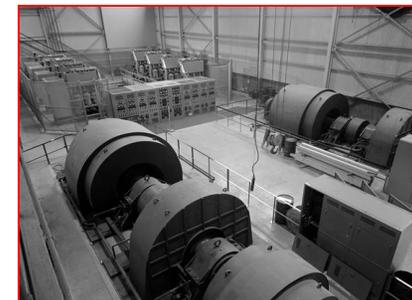
- Motor generators ramped up the magnet in 1.85 seconds for each 5 second cycle.
- It used a **lot of power**, this cost a lot and led to its demise.

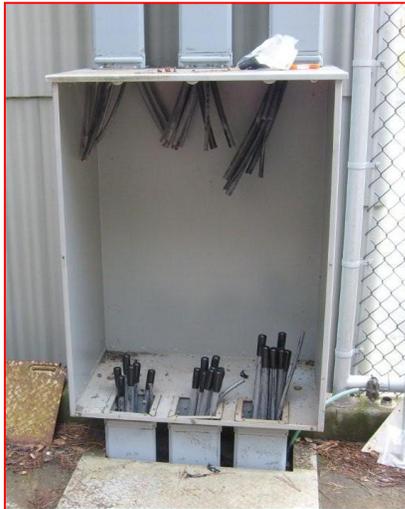
They established a boundary where all utilities had to be severed and then worked outward from there to where isolation breaks could be implemented.

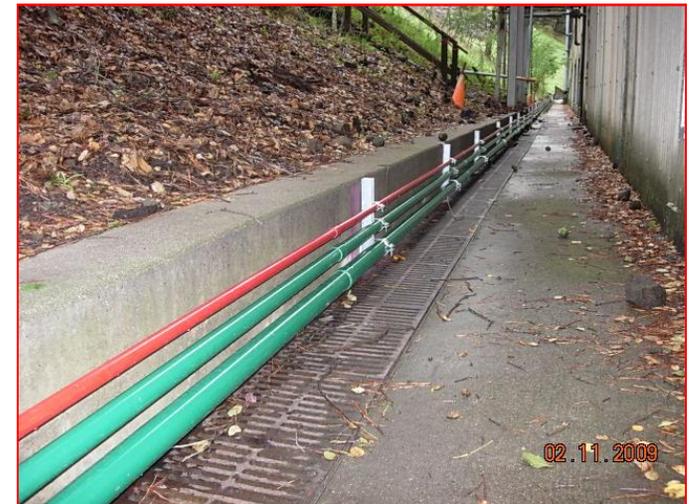
Re-establish Reliable Utilities

In order to work in the building they needed power and other utilities that were reliable and manageable.

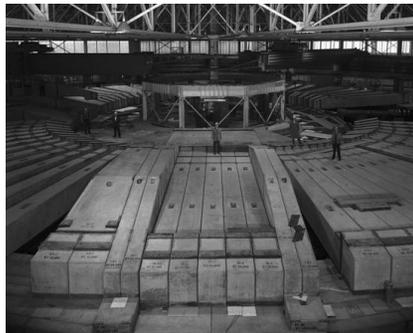
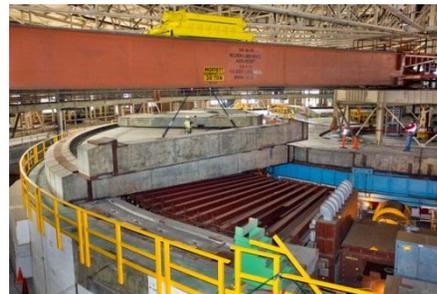
Milestone 2: Remove Shielding Blocks

- Removed shield blocks
- Used existing lift points
- Rad characterized
- Packaged
- Disposed per WMP

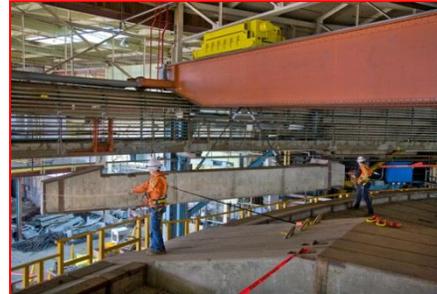
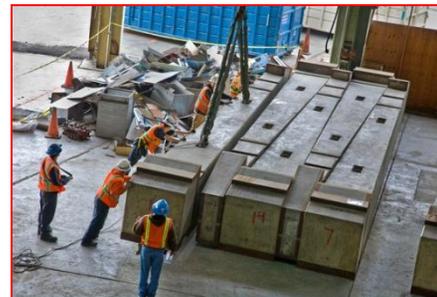
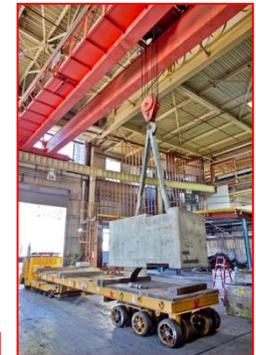
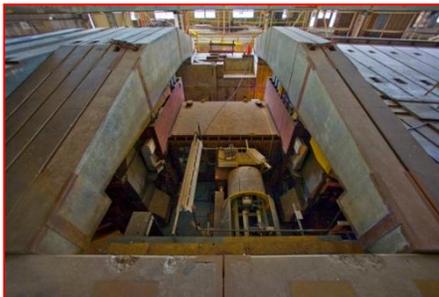
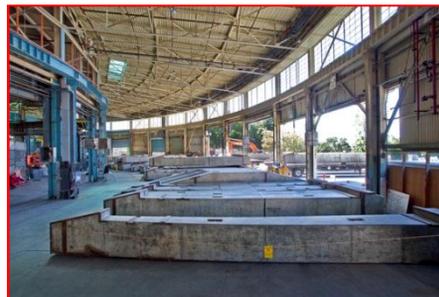
Milestone 2: Remove Shield Blocks

- Removed shield blocks
- Used existing lift points
- Rad characterized
- Packaged
- Disposed per WMP

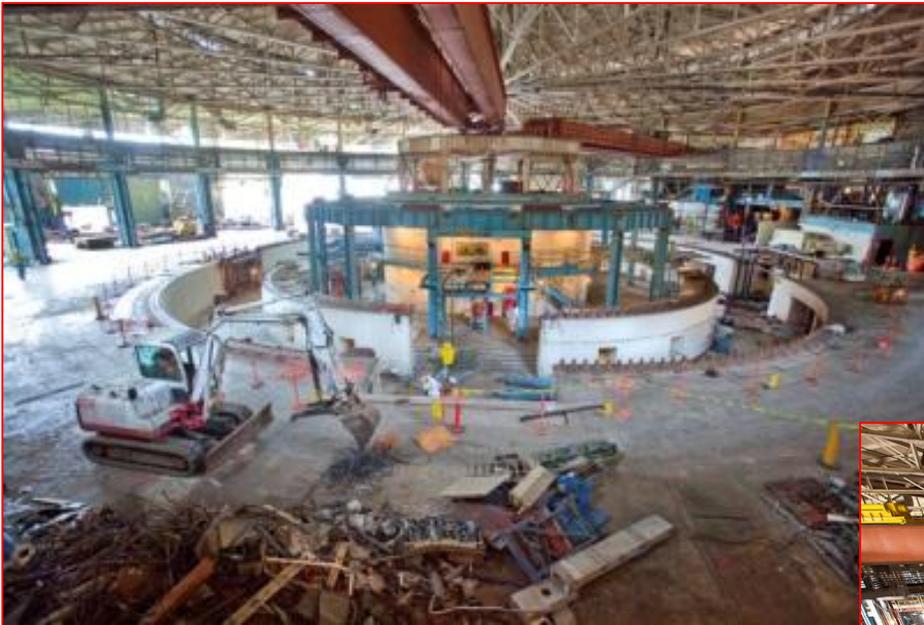
Milestone 2: Remove Bevatron Accelerator

When the Accelerator was removed then the interior of the building was cleared.

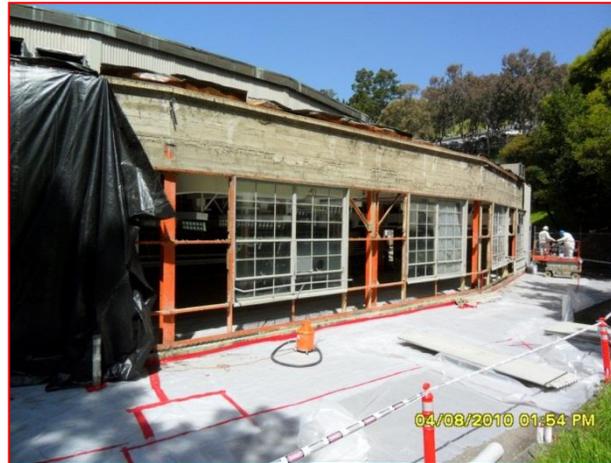
Milestone 3: Abate Hazardous Materials

Before the building super-structure was demolished there was abatement of the structure's interior & exterior.

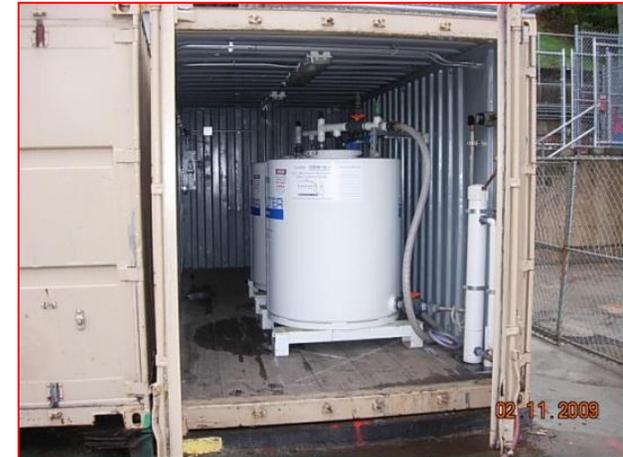
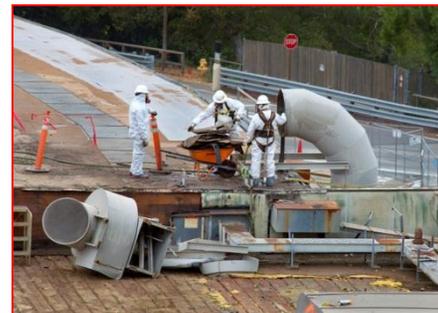
Then they removed stored hazardous materials.

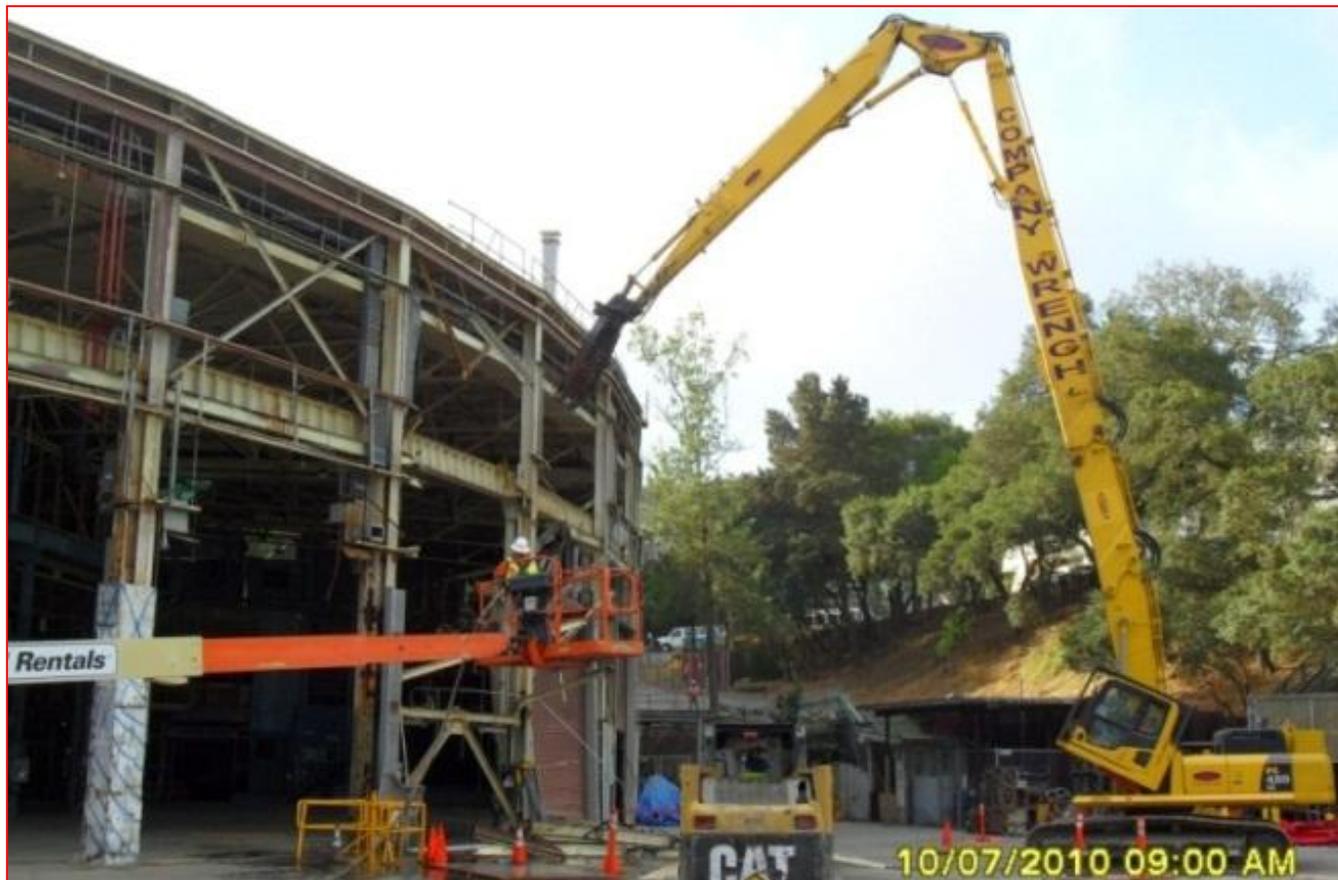
- The building super-structure was pre-weakened.

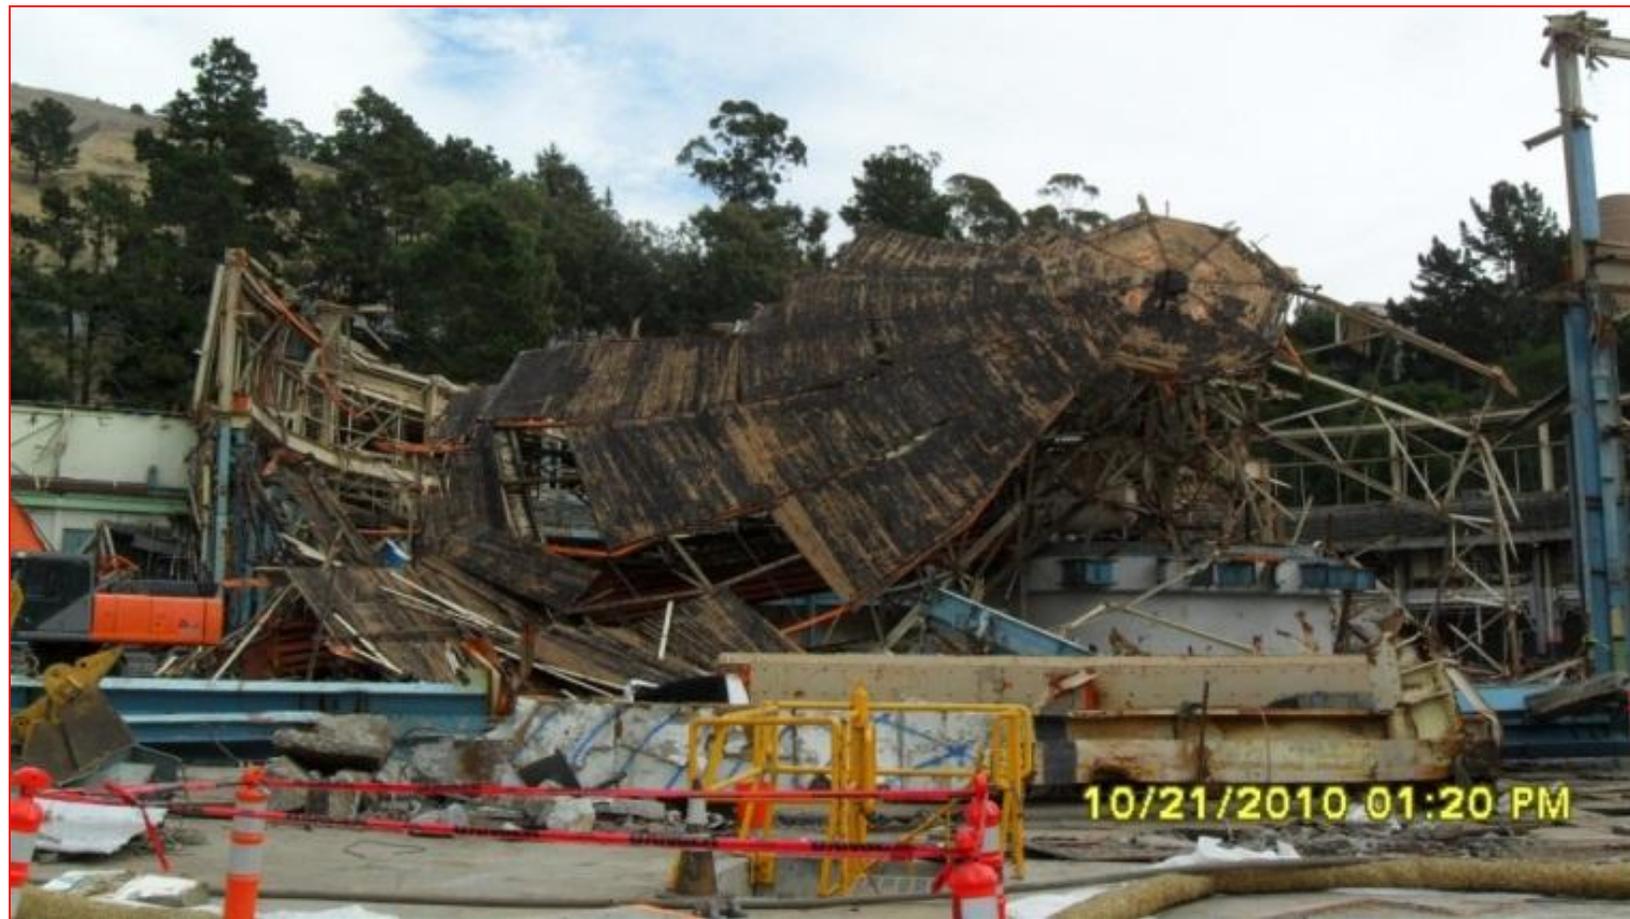
The super-structure was brought down in a controlled drop.

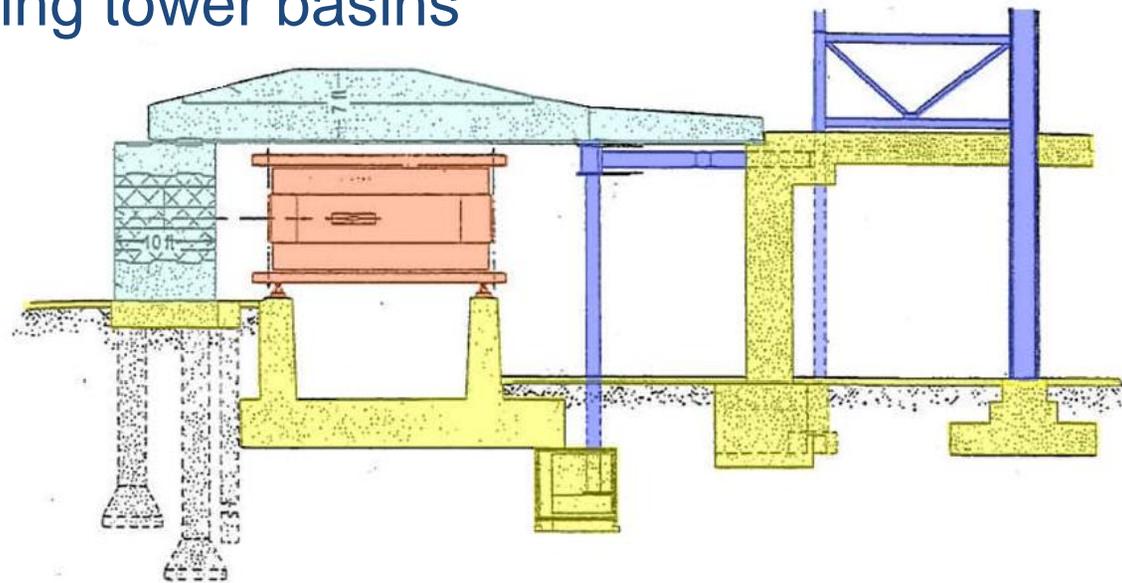
- Removed foundation system including pile/caisson caps, grade beams, shallow caissons, and facility floor
- Demolished deep tunnel
- Removed cooling tower basins

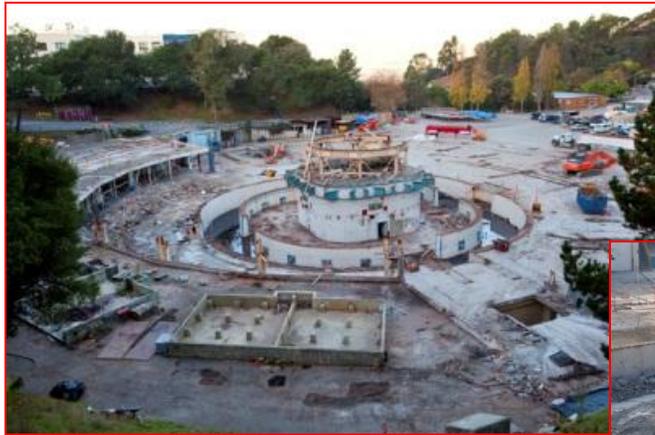
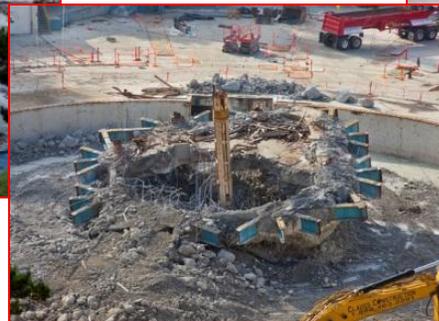
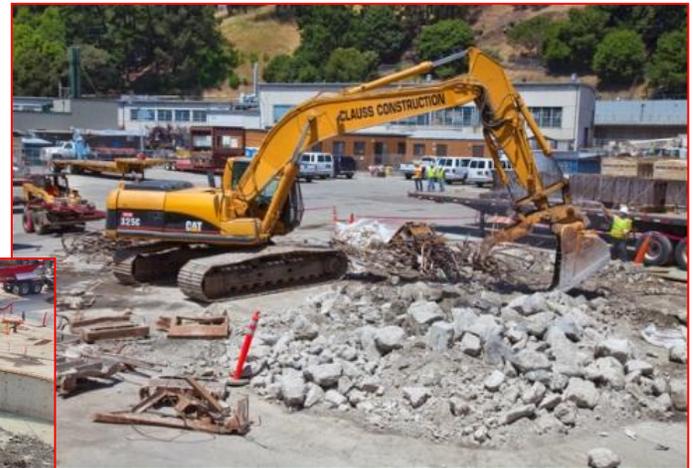
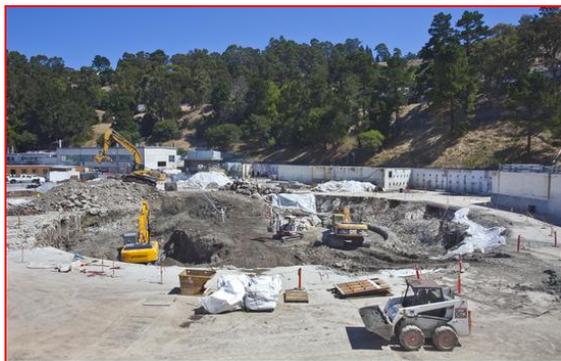
Milestone 5: Remove Foundations and Slabs

This process took over a year to complete because they had to methodically manage the hazards in the foundations and the soil.

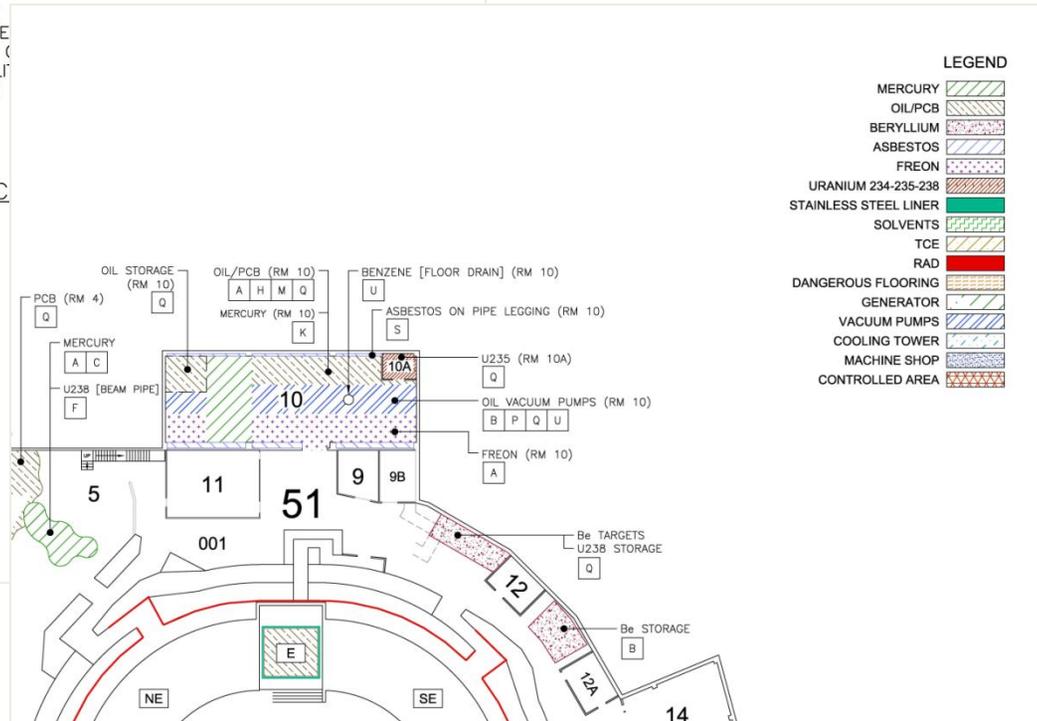
Developed a Hazard Map

- Interview personnel involved during operations
 - Operators
 - Scientists
 - Technicians
 - EH&S
 - Fire Department
 - Construction crafts
- Combine the information into a map of the facility
 - Areas of known contamination
 - Areas of prior clean up
 - Areas of suspected contamination

- Map was provided to the contractor to conduct samples of each area to characterize found hazards.

- Map was provided as a bid document to demolition contractor to inform their remediation efforts.
- The contractor was able to segregate the hazard, reuse material (soil) and backfill the excavation site.

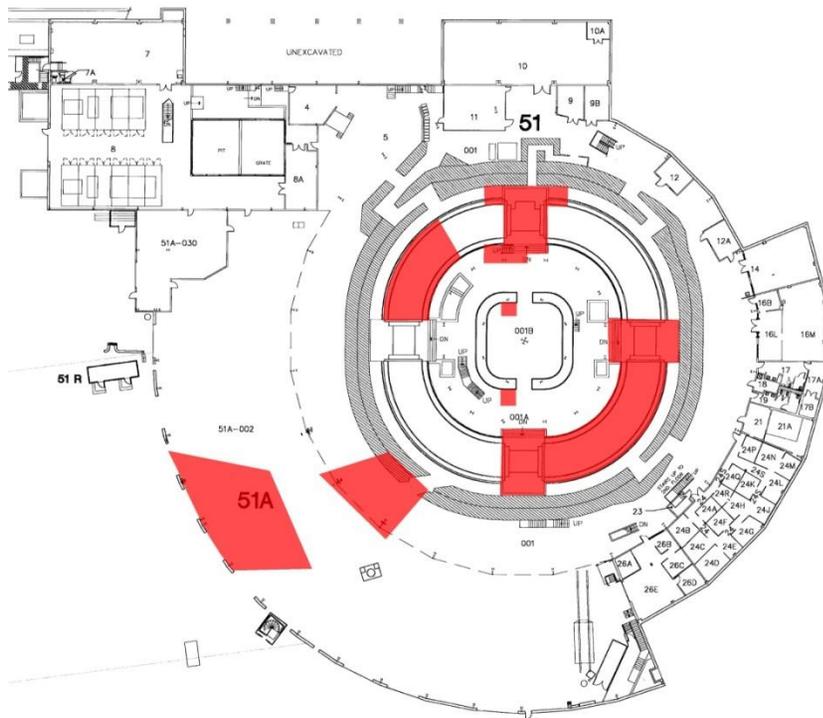
Initial Protocol Estimate

- They expected very few surface contaminated objects
- Activation products were predicted to be in:
 - Accelerator components, concrete shield blocks, floor slabs and foundations, and steel structures
- For The Blocks
 - Initially DOE OK' d characterization protocol
 - They used handheld Na-I, set a MDC of 2 pCi/g
 - They used a "clean" reference block for a baseline
 - An external lab analyzed the reference block (No MDC)
 - Found activation products < 2 pCi/g in reference block
 - DOE revised the protocol-said had radioactive material

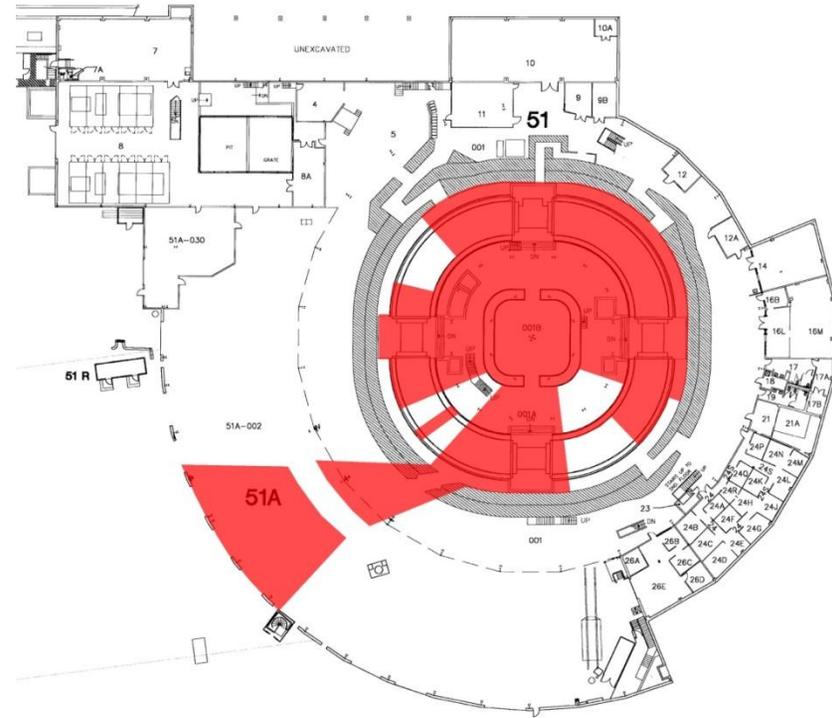
Revised DOE Protocol

- Under revised DOE protocol
 - Had expected to **release** 60% of shielding blocks;
 - Actual blocks **release** reduced to 20%

- Had expected to **release** ~75% of slabs and foundations;
 - Actual slabs and foundations **release** reduced to ~20%
- This impacted remediation of blocks, slabs and foundations and cost several millions (~10) more
- Lesson - Specify MDC early, clearly & oversee analysis

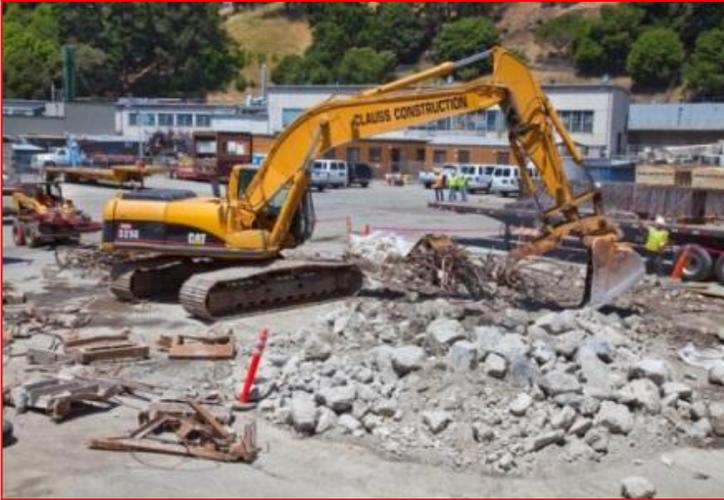
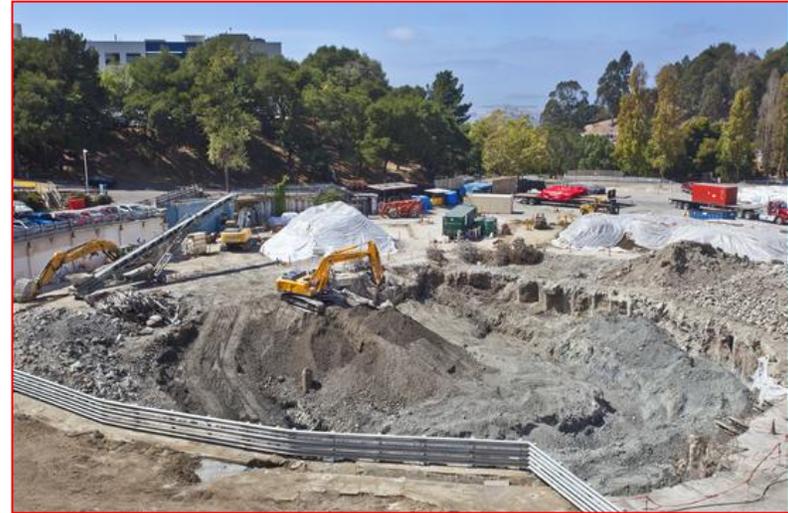
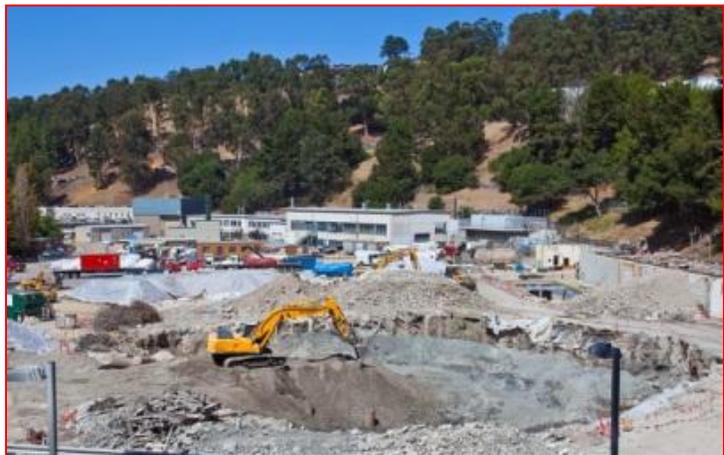
Milestone 6: Remediate soils and then backfill

Debris
segregated
for
disposal or
for backfill.
